Queen's Marine Service Report

Name of Vessel : MV Atlantic Huron
Name of Contact : Sergiy Katayev
Owner's Name : CSL
Equipment : Lips OD box
W.O. # : SW-07-1443
Place of Attendance : At Anchor off Sarnia
Date of Attendance : 06/27/2020

SUBJECT: Atlantic Huron O.D. box report

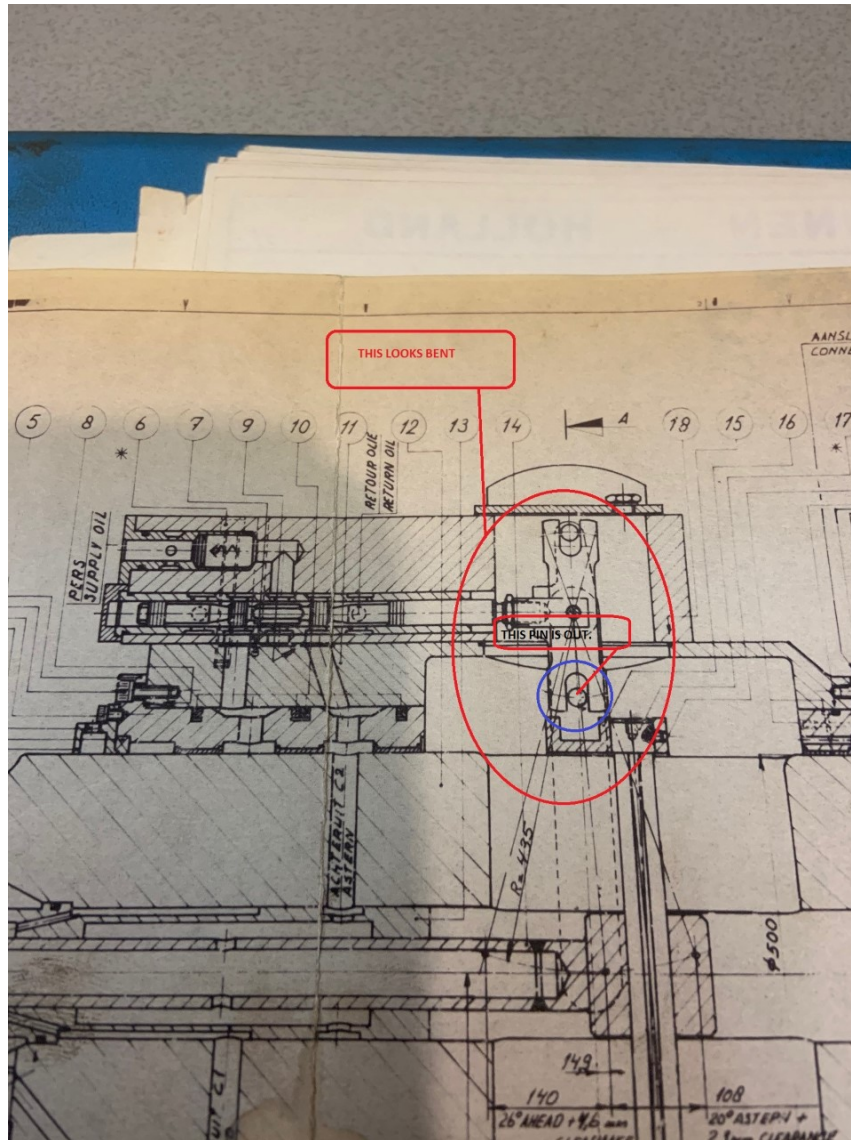
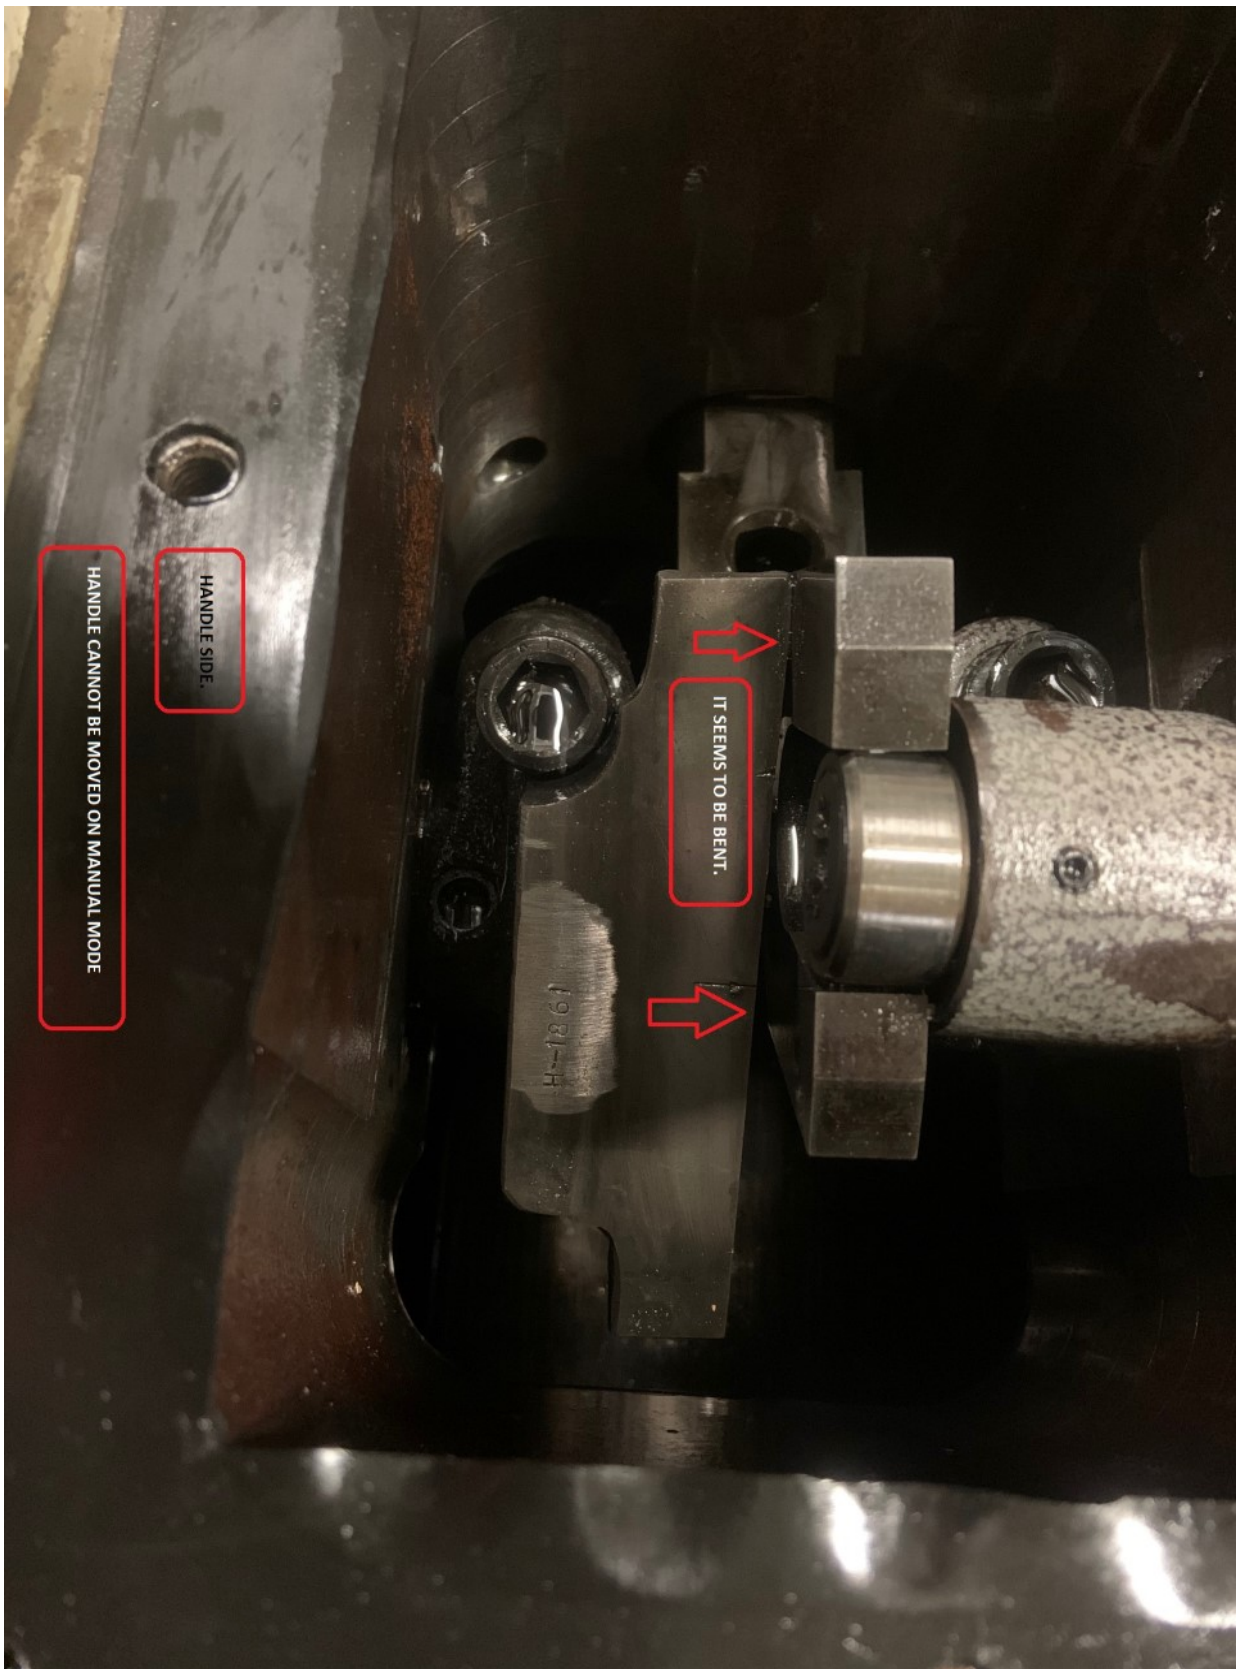
When we got to the vessel the chief had already removed the top cover of the o.d. box. You could see that the bottom bearing on the feedback rod had come out of its position and was jammed against the side of the feedback arm. This deflected the arm in such a way that it went full ahead and seized in this position.

As we were checking the o.d. box to find out why the bearing was able to move completely out of its slot in the feedback arm. It was found that the o.d. box unit was able to be moved axially on the shaft at least an inch or more. This is the result of a worn out torque stand. I was able to make some shims and wedged them into the worn area of the torque stand and secured them using a hose clamp. This is a temporary repair and must be repaired properly as soon as possible or similar failure may occur. To aid in preventing failure pitch control should be limited to 75 percent.

I removed the actuator arm and the manual control arm from the outside of the o.d. box. I used a piece of threaded rod and a spacer to draw the shaft out from the feedback arm inside the o.d. box. Once the shaft was removed we could then move the arm to release it from where it was jammed and remove it for further inspection. Once it was removed everything that appeared to be bent straightened back into position. The feedback arm had some minor damage from being jammed and the bearing was damaged. I visually checked the arm for cracks and straightness. The arm had no cracks and appeared to be straight. After cleaning up the minor damage and replacing the bearing with a spare the chief had it ready to be reinstalled. The shaft also was checked for damage and straightness in a lathe. The shaft had no damage and was straight and was able to be reinstalled.

The o.d. box was reassembled and filled with oil. We tested pitch control both ahead and stern.
